Gariwerd assessment update

Project 4	Environmental impacts assessment at rock climbing sites
Lead	Parks Victoria
TO involvement	Yes, engagement on assessment results
Aim	To gain an understanding of the total area of vegetation impacted and removed in the vicinity of rock-climbing sites; and to document the nature of other disturbances (other than vegetation removal) at rock climbing sites.
Key results	<ul style="list-style-type: none"> • Eight climbing sites were assessed - covering a range of geographic areas, climbing types and levels of use. Impacts were examined along access tracks and at the base of climb sites but did not include any impacts on walls or cliff faces. • All 8 sites surveyed showed evidence of disturbance along tracks and at activity areas. • Impacts detected included vegetation removal/damage, evidence of fires, rubbish, toilet waste, track formation and weeds. Cause of damage at climbing sites was not able to be identified nor attributable to any single source. • For the 8 sites (of the estimated ~200), vegetation loss of 0.72 Ha was detected in total. • Extrapolation of findings to the ~200 sites predict approximately 179,660 m² (18 Ha) of vegetation impact

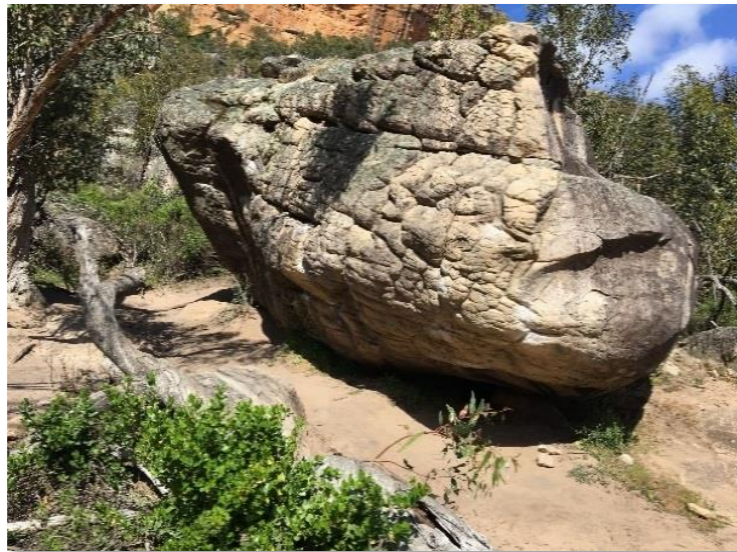
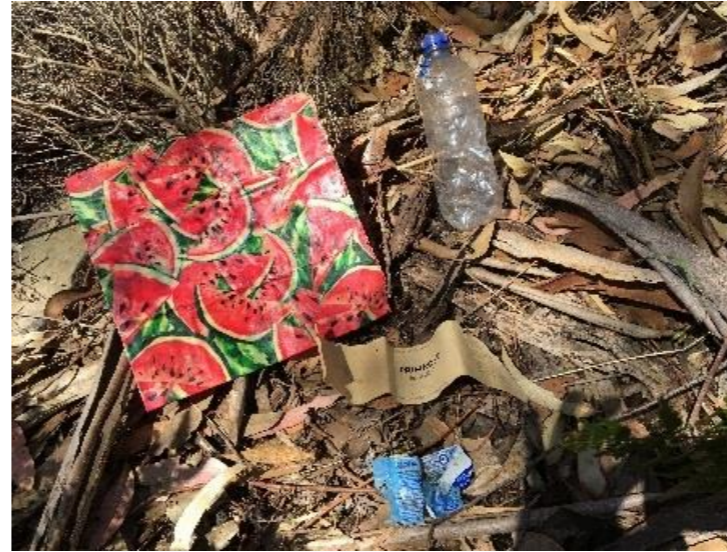
A warning for anyone looking to (literally) jump on Manic Depressive at Bundaleer, Grampians. On this past weekend a significant chunk of the starting jug, the one that everyone jumps off the stool to, broke off. And theres some serious cracks showing on what's remaining of the hold. So unless you really want to kill your belayer, or yourself, dont jump to it. Please.

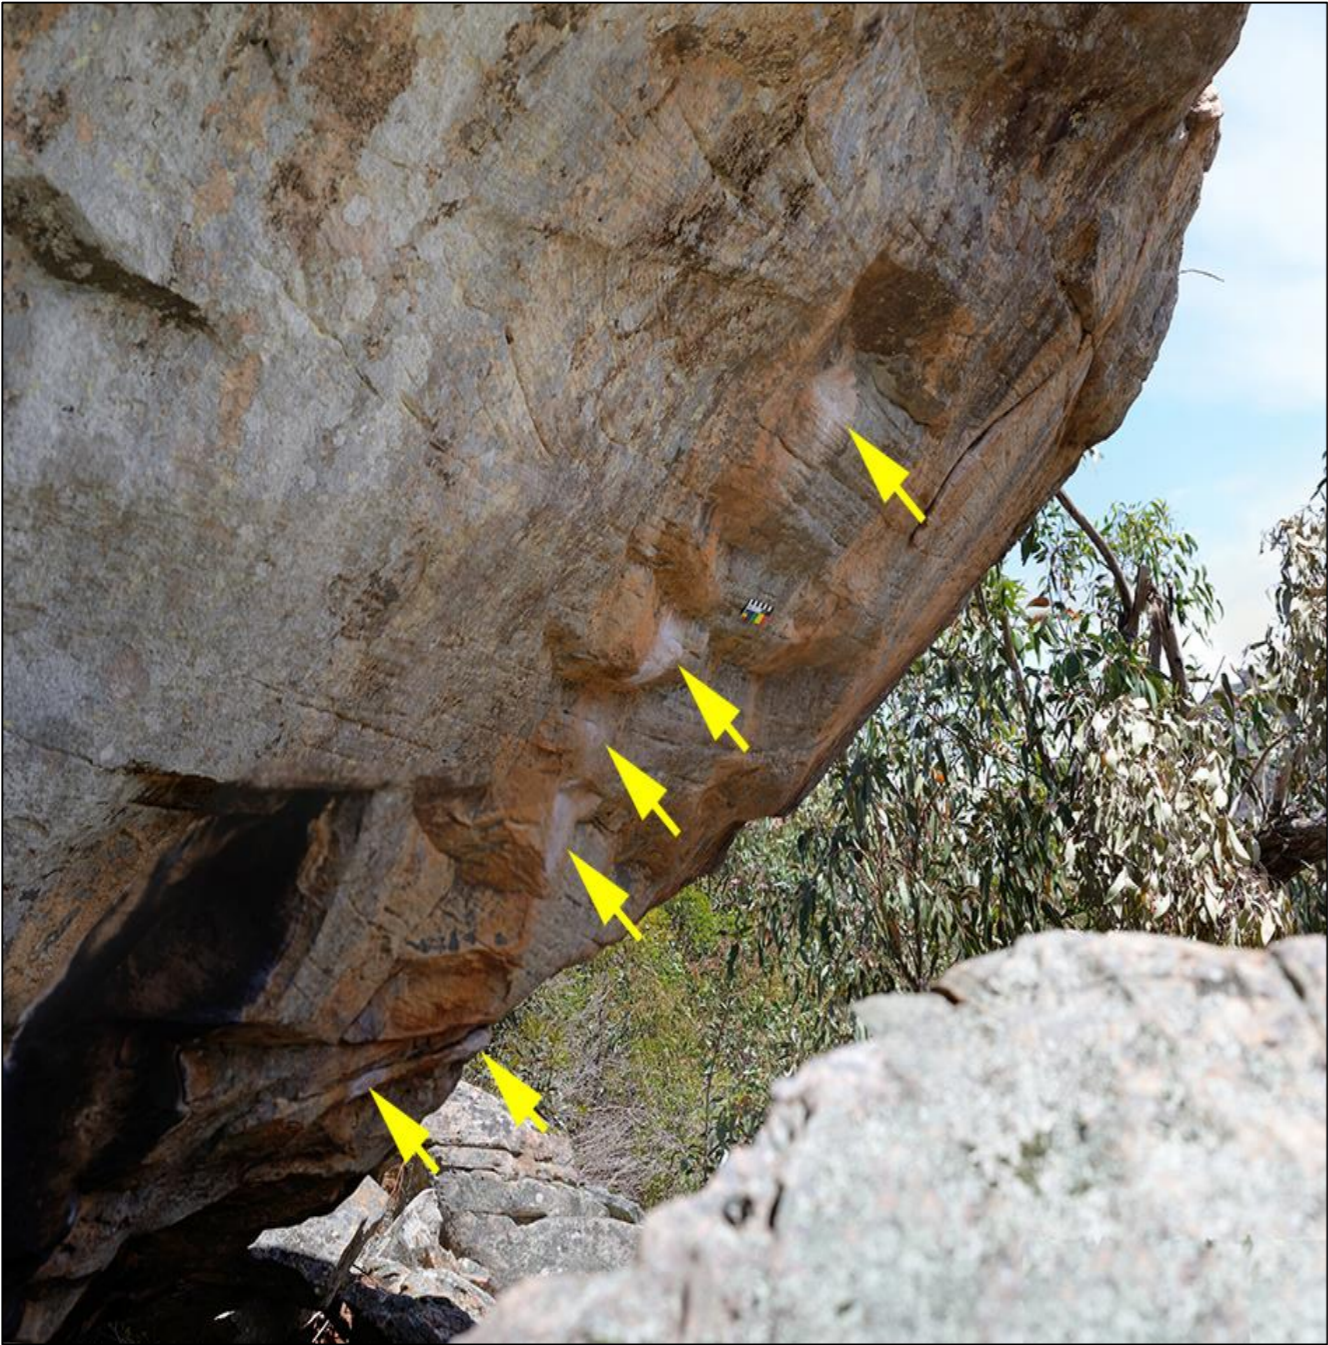
Column of chalk marks within the shelter of the Flat Rock art site. The chalk build up is dense suggesting repeated climbing.

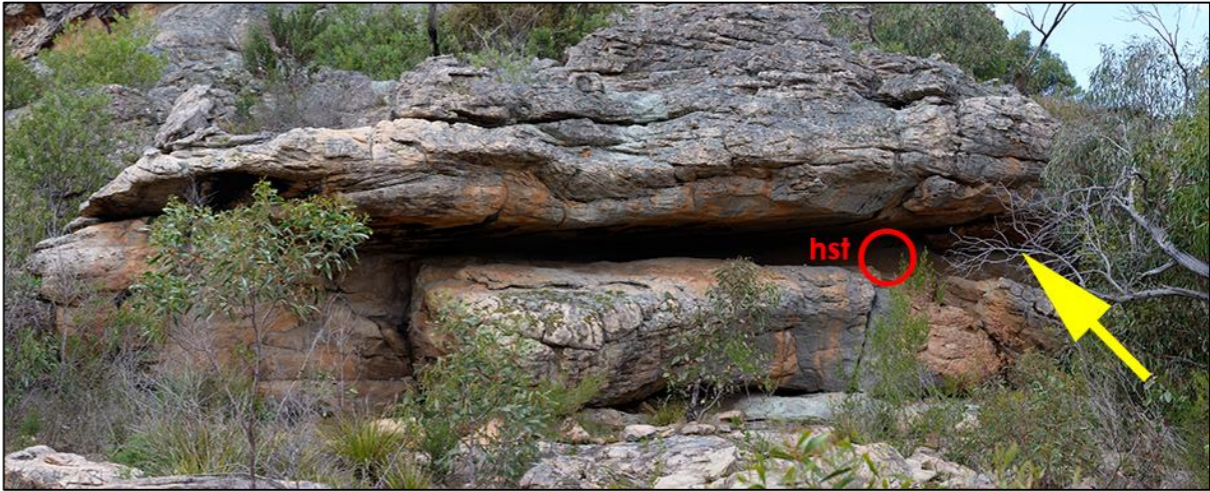
There is a chalked area is 3.5m west of the closest hand stencil.

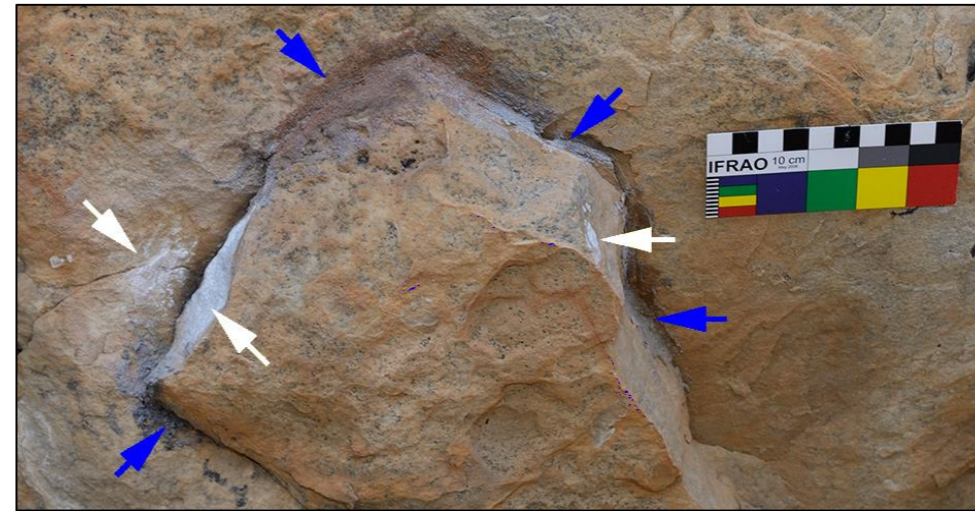
Chalk marks (white) and adhesive remnants (blue)

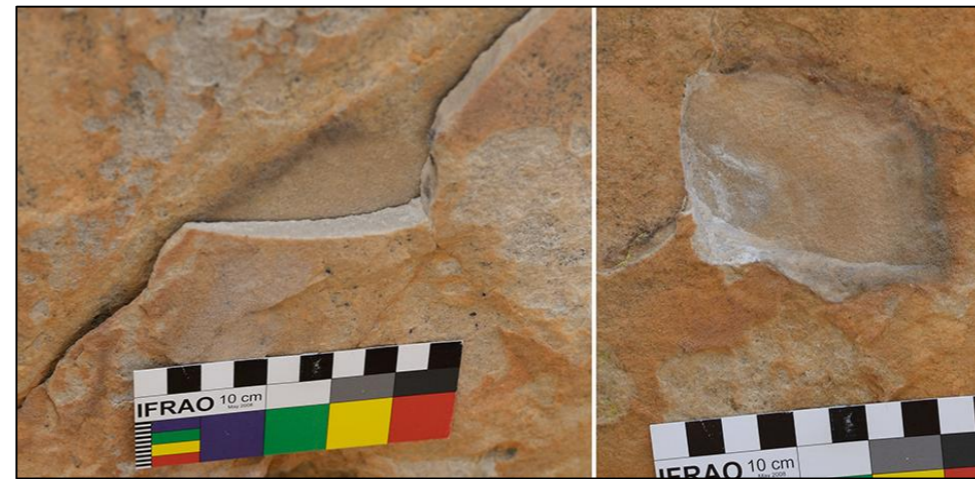
Two examples of recent rock damage

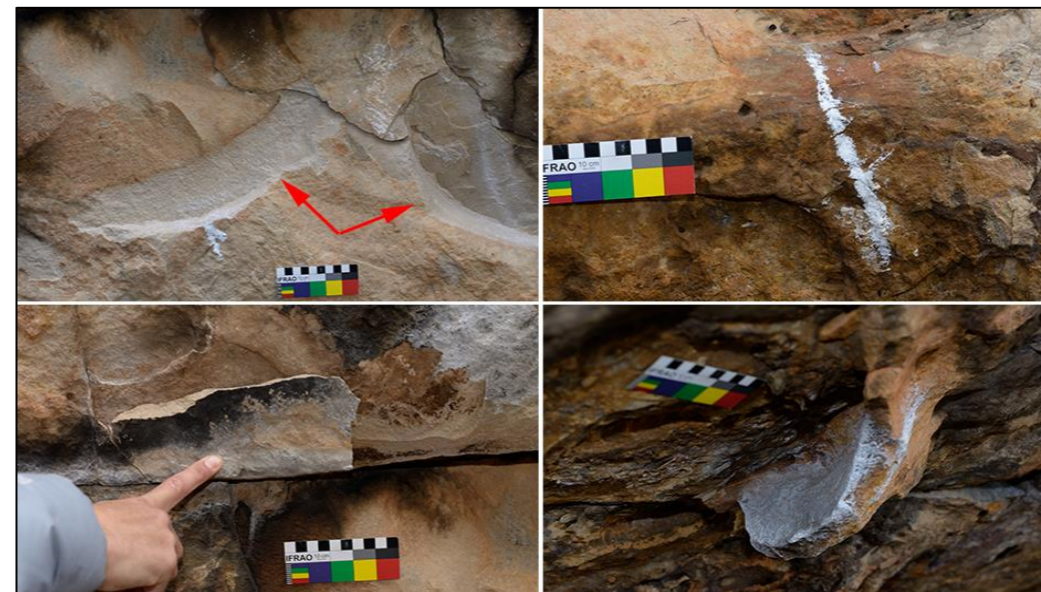
Further chalking evident in three adjacent rock shelters all located within 50 metres (and within the SPA).

The shelter has suffered serious damage as a result of bouldering. Four instances of bouldering chalk were located in the art shelter (1.8m east of the art). Four rock breaks consistent with bouldering damage were also present within the shelter. A cement-like material appears to have been applied in conjunction with the chalk.

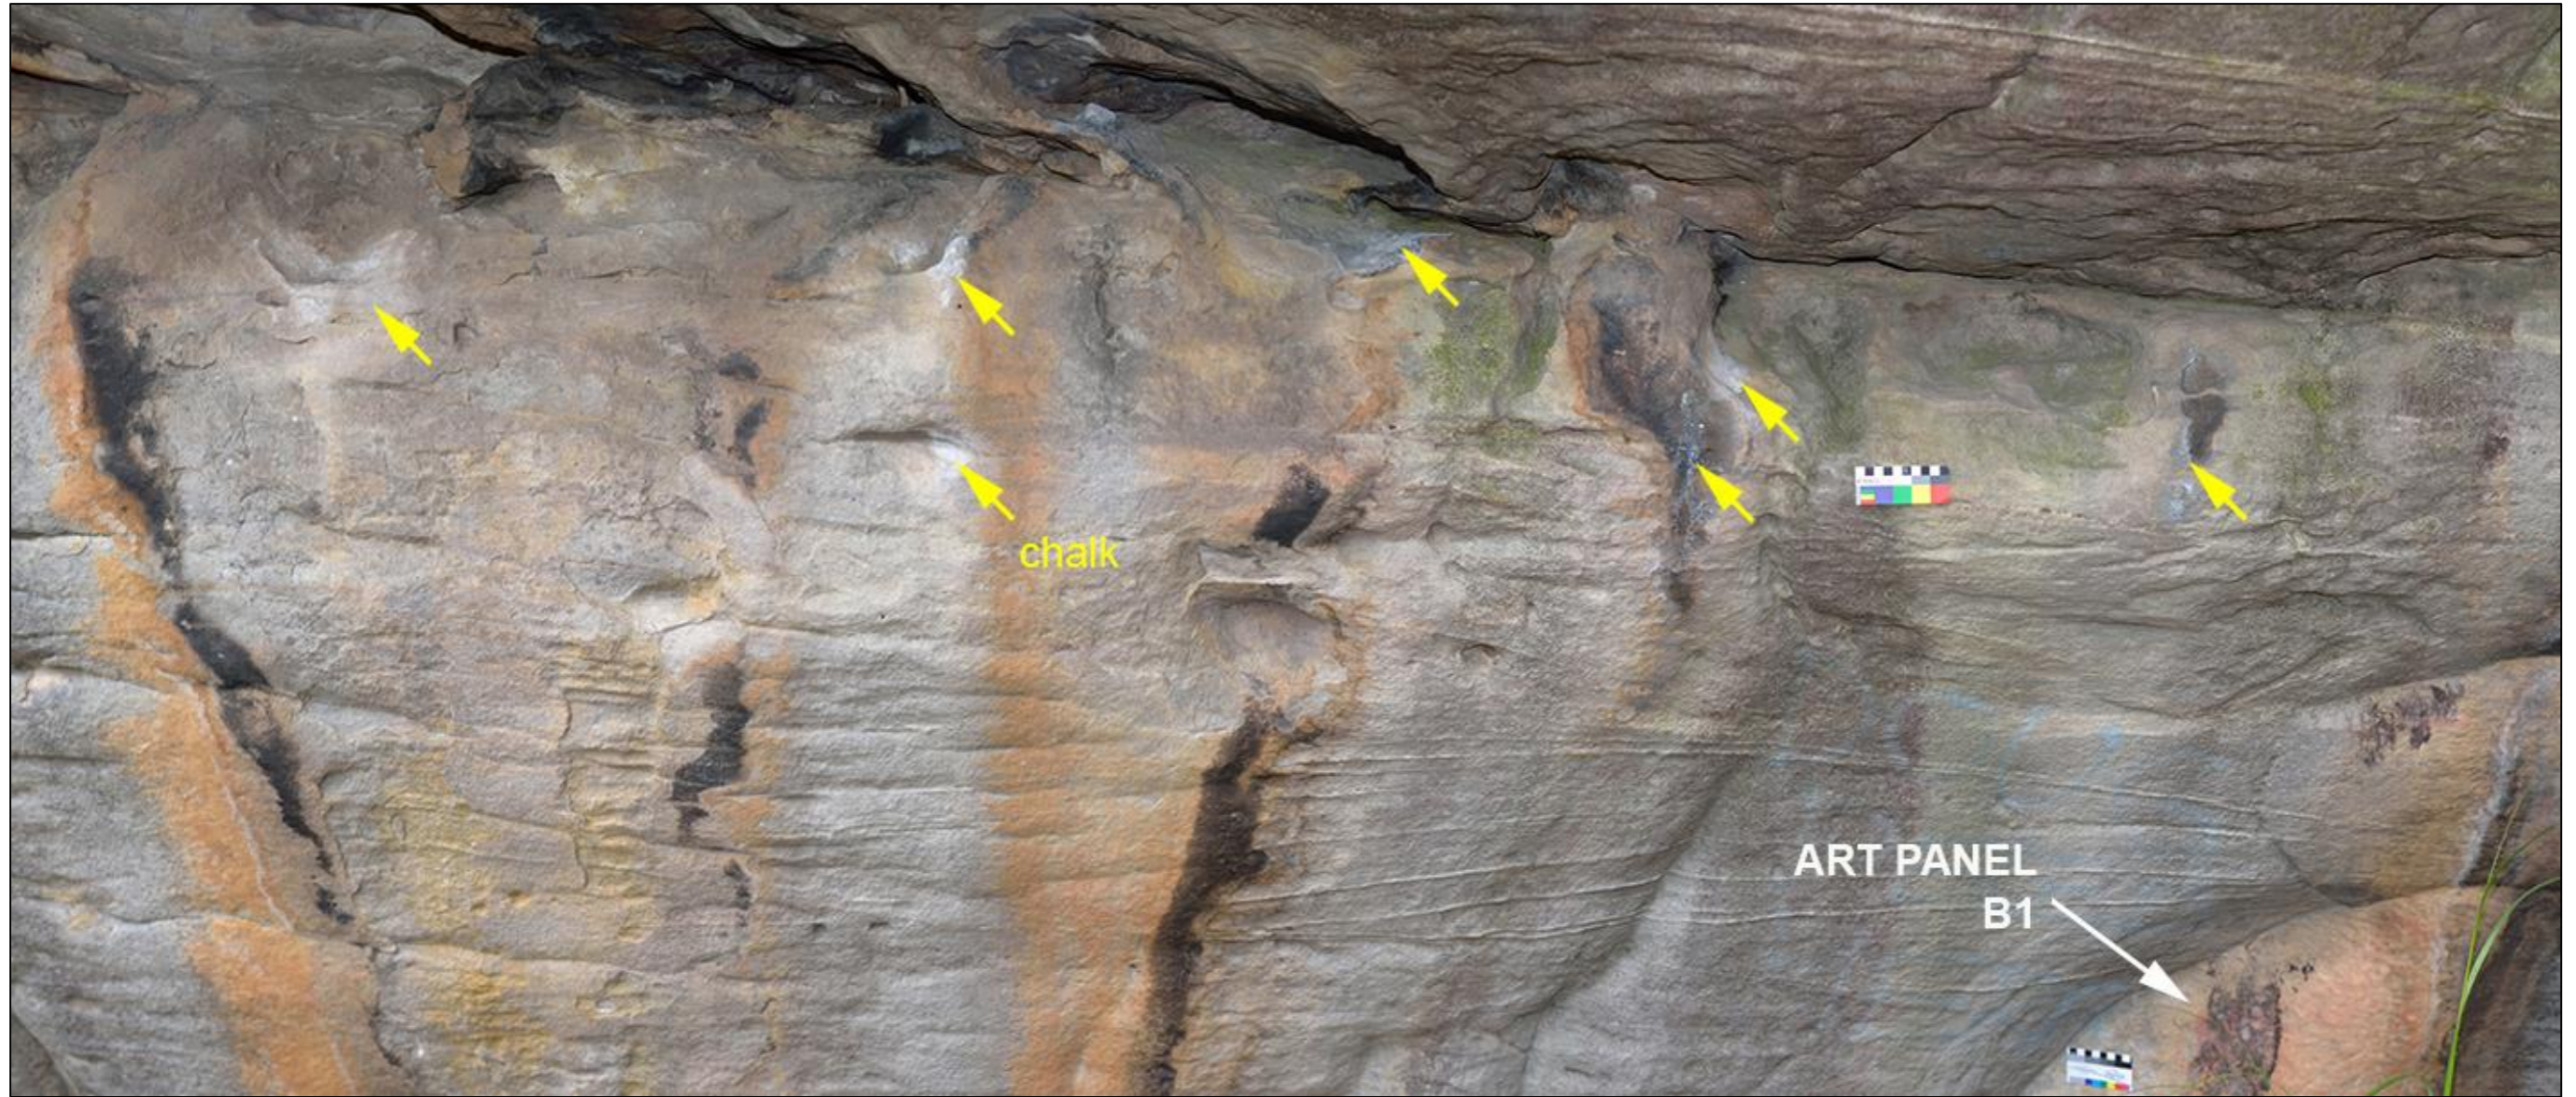
Seven instances of bouldering chalk detected along a horizontal ledge above the art panel

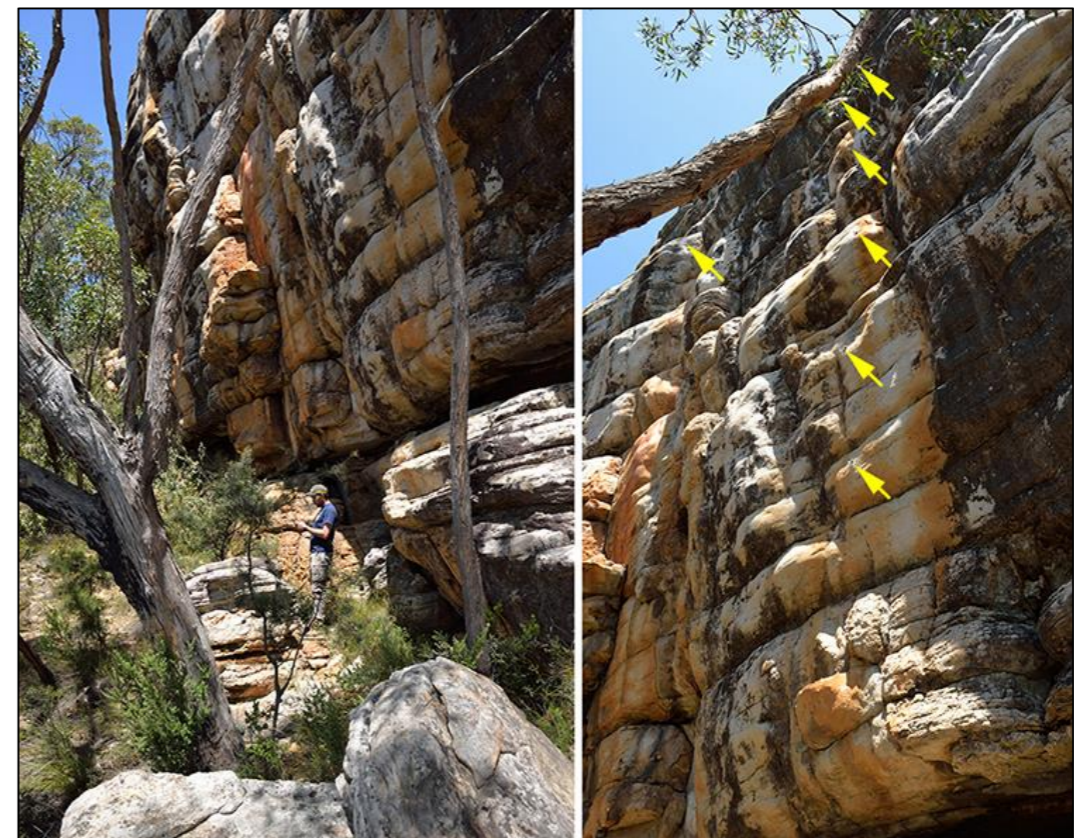
Gilham's shelter exterior wall showing location of visible climbing bolts

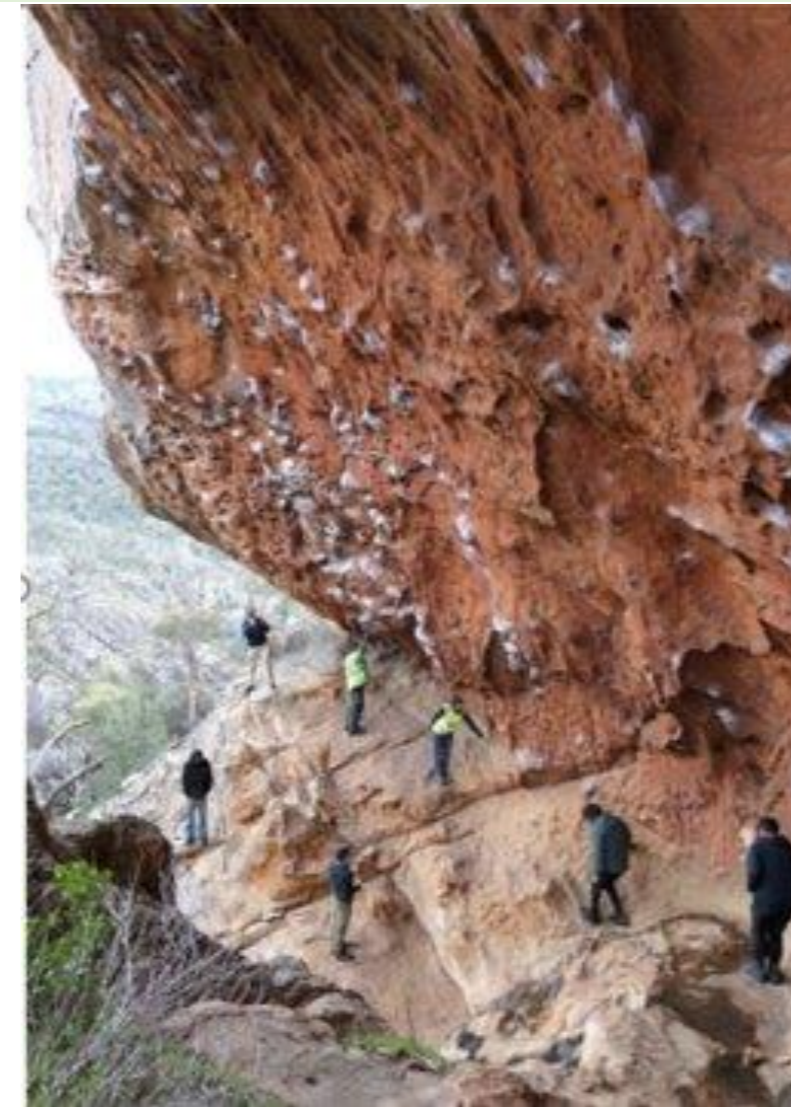
Chalk marks within the Gallery shelter – a registered stone quarry site
